March 4, 2022

Radon Survey Report – Schools/Commercial Buildings

640 SW Bancroft St – The Cottonwood School
Portland, OR 97239

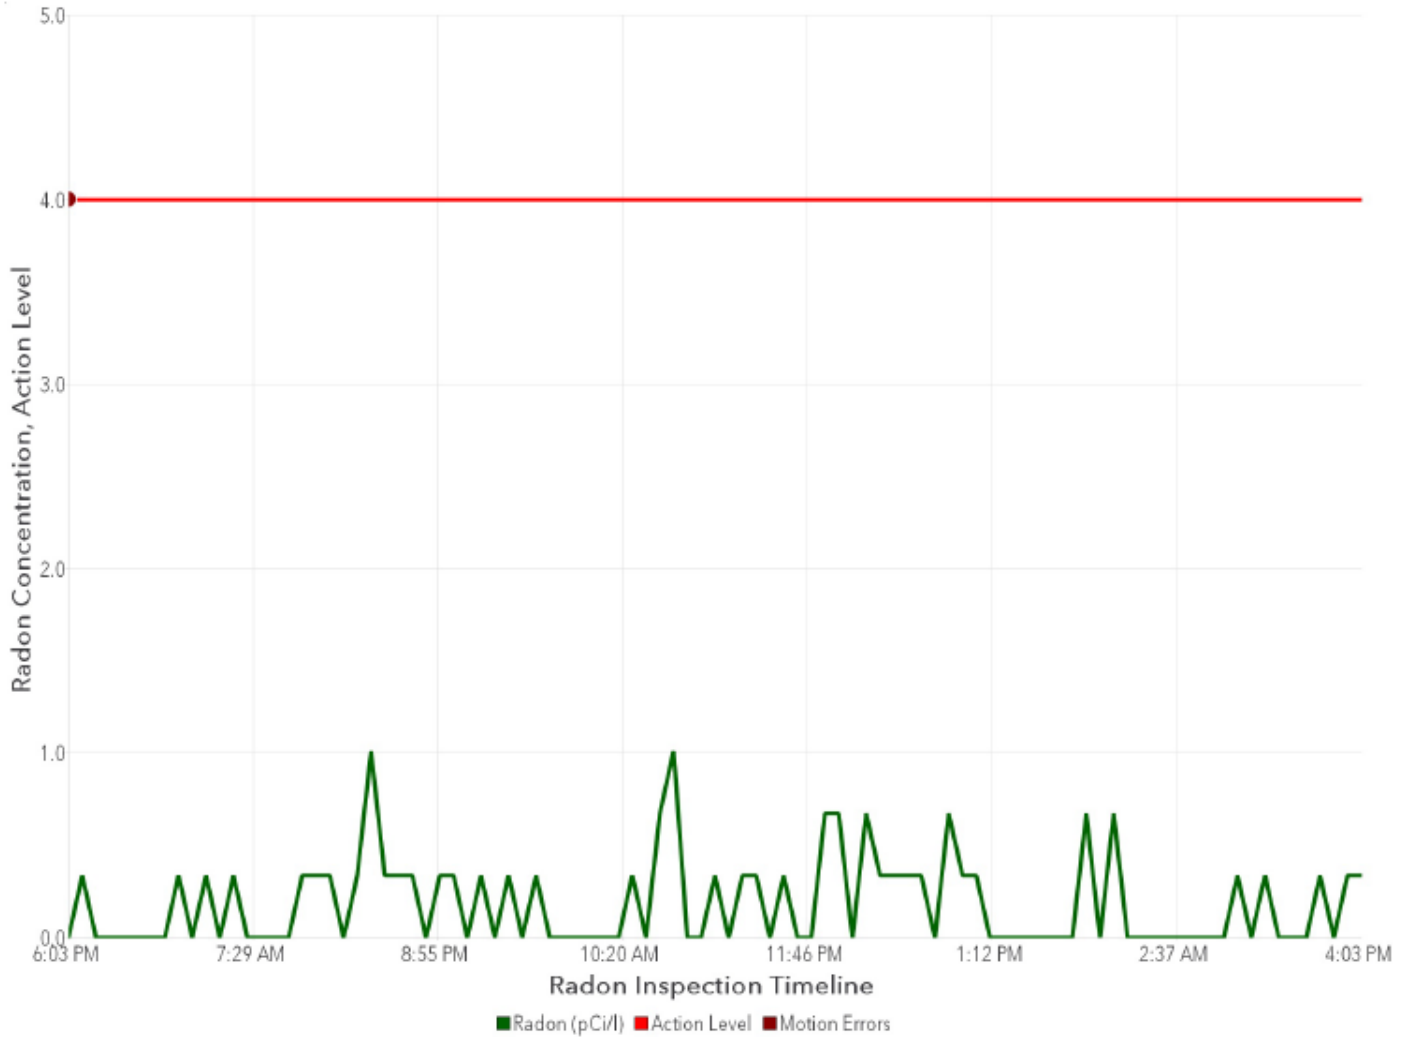
Graph 1: Radon Inspection Chart – CRM Data (Test Location – CENTRAL HALLWAY)

0.2 pCi/l

CRM Location: Central Hallway	Start: 02/11/2022 05:03 PM	Stop: 02/15/2022 04:03 PM	Interval: 1 hr	Duration: 95 hr
Radon Concentration:	Min: 0.0	Max: 1.0	Average: 0.2	Measurement Units: pCi/l

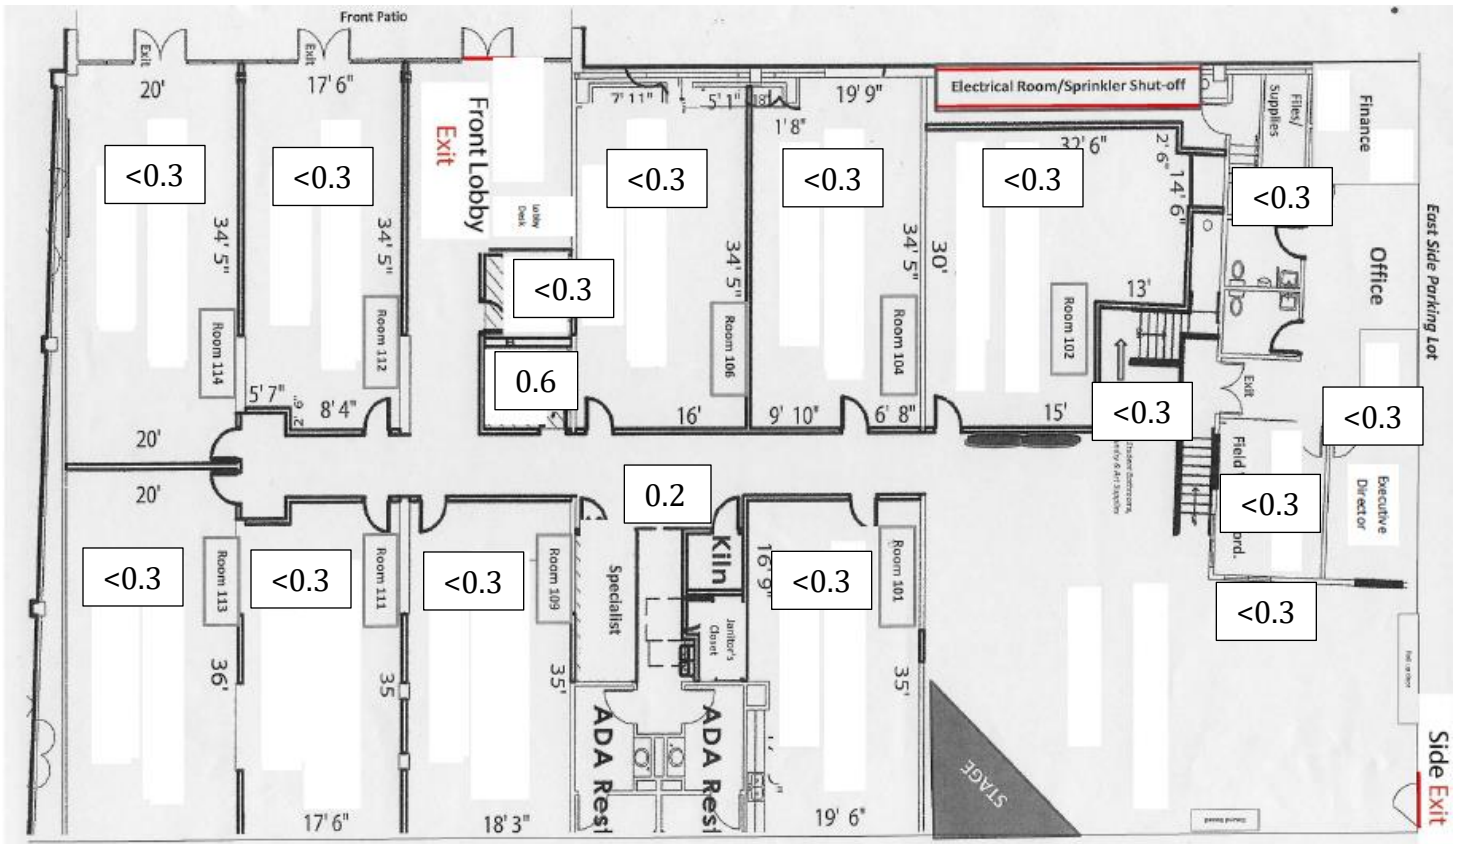
Figure 1: Site Map of Radon Survey Results (Figures in pCi/L)
The Cottonwood School Layout

COMPANY NAME	Environmental Works, LLC
TEST DATES	February 11 – 15, 2022
REPORT DATE	February 27, 2022
PROPERTY	The Cottonwood School
CLASSROOM / TEST LOCATION	
UTILITY	< 0.3
110 - COMP LAB	< 0.3
102	< 0.3
101	< 0.3
104	< 0.3
105	< 0.3
106	< 0.3
107	0.6
108	< 0.3
109	< 0.3
111	< 0.3
112	< 0.3
113	< 0.3
114	< 0.3
GREAT ROOM – NEAR HALL	< 0.3
GREAT ROOM – NEAR STAIRS	< 0.3
AMANDA'S OFFICE	< 0.3

1. **QUALITY CONTROL** measures indicate no error in laboratory analysis or batch contamination.
2. **BUILDING AIR PURIFICATION SYSTEMS IN OPERATION DURING TESTING** likely to be contributing to increased air circulation and potentially reduced radon concentrations.
3. **MITIGATION NOT RECOMMENDED** as all test results came back below the EPA Recommended Action Level of 4.0 pCi/L. Re-testing every 2 to 5 years is suggested and following any major structural, mechanical, or other changes to the building systems.
